December 2, 2021

RE: Revision 1 - Report of Geophysical Investigation
[Crystal Lake Sinkhole Investigation \(Cherokee Dam\)](#)
152 Tomahawk Trail, Winchester, VA
VEPC Project No: PTL-212862

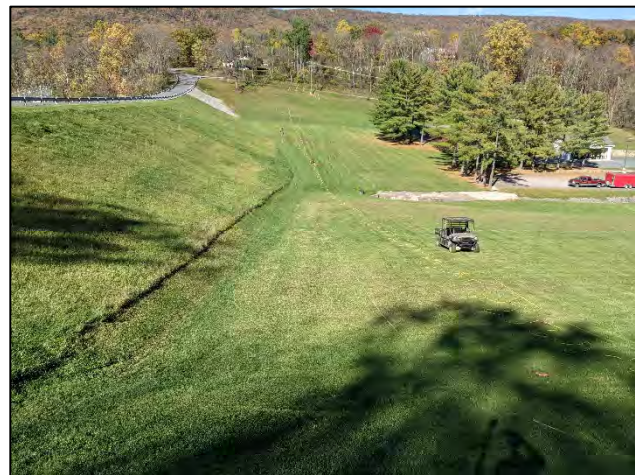
Figure 2. ERI Field Investigation

A three-dimensional ERI survey along [six \(6\) parallel lines](#) running east to west along the downstream slope and toe of Cherokee Dam. The study included a [dipole-dipole](#) array resistivity survey utilizing the Advanced Geosciences, Inc. (AGI) SuperSting R-8/IP Passive Earth Resistivity System. The ERI lines were spaced approximately 16 feet apart with a length of 664 feet each. The resistivity lines were established with an electrode spacing of 8 feet to gain a maximum resolution and imaging depth of approximately four (4) and 130 feet, respectively. Anomalous resistivity zones were mapped in an effort to identify flow paths which traverse the survey area to distinguish potential remediation areas. Further, resistivity imaging data was processed and inverted using AGI's proprietary 3-D resistivity inversion software, EarthImager 3-D, to generate the inverted resistivity sections. Terrain correction was performed utilizing high resolution elevation data obtained from USGS 3DEP one-meter Light Detection and Ranging (LiDAR) bare earth elevation maps. Electrodes were located in the field with multi-band RTK GNSS receivers with a nominal location accuracy of less than three (3) centimeters.

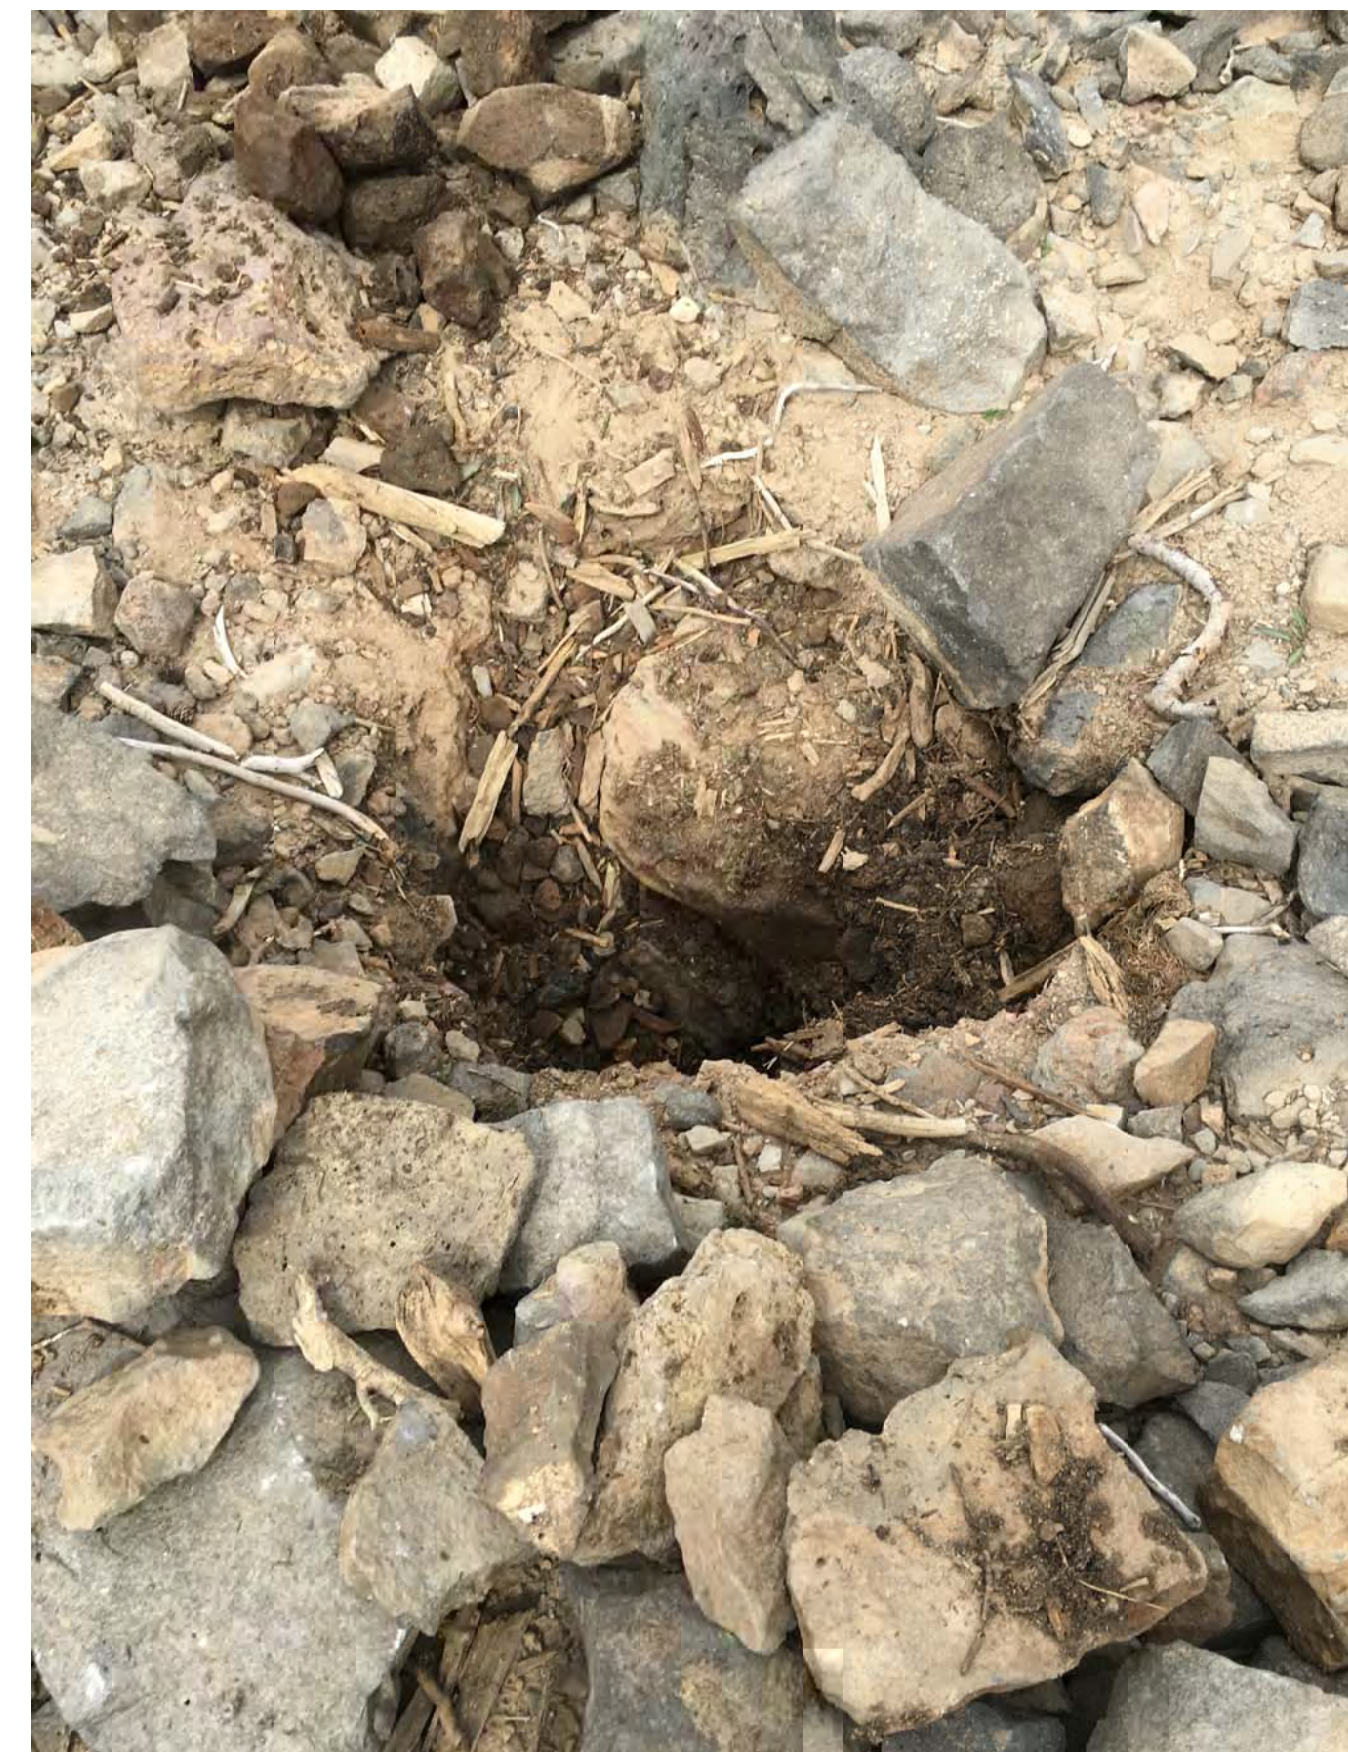
NEW SEEP HOLE

The seepage area is on the right shoreline in natural material some distance away from the left groin and approximately 4 to 6 feet east (or right looking downstream) of the 2009 liner patch and seepage repair. It is likely that seepage in this area is following in the natural fractures of the basalt or is simply flowing between basalt boulders. According to Gerry Figueroa, the flow was observed to emanate below the toe of the embankment. From previous observations, it is also known that some seepage shows up in Leon Creek at higher reservoir levels, suggesting multiple natural seepage paths. Reportedly, no soil deposition has been observed at the measurement points below the dam suggesting that the removal of fines may be a near surface phenomenon. It is feasible that the near surface fine grained material in the fractures or between the boulders has washed out and the previous seepage flow path has been restored.

The recommend repair is to extend the liner system patch approximately 20 to 25 feet to the east by carefully exposing the right side anchor trench. The new liner system patch will be installed in a similar fashion to the 2009 seepage repair and utilizing the adjoining anchor trench as shown on Sheet 1 and Sheet 2. To try and eliminate the previous seepage flow path, a two
